Case Study

Wylfa Newydd bat barns, wildlife towers and owl barns

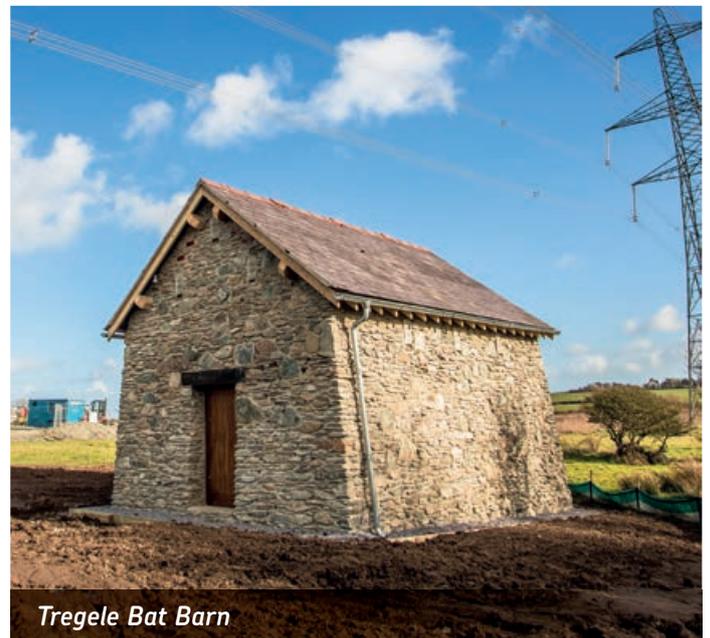
Tregele Bat Barn

In 2017, a second bat barn was constructed by Horizon in a field east of Tregele using a similar design to the successful first bat barn. This building also made use of materials reclaimed from previous demolitions.

Along with a third bat barn due to be constructed on the eastern edge of the Wylfa Newydd Development Area in 2018, the Tregele bat barn will compensate for proposed building demolitions associated with the Wylfa Newydd project. These bat barns will eventually be linked by a network of new habitats created as part of the landscaping works for the proposed power station.

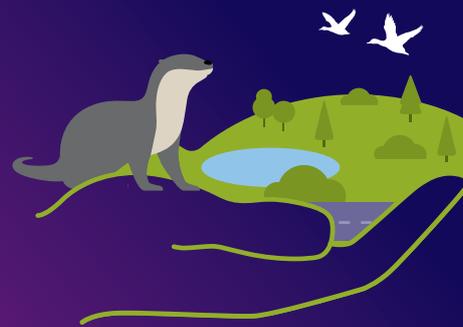
In 2013, Horizon built a wildlife tower at Cafnan Farm to further compensate for building demolitions required for health and safety reasons.

The wildlife tower was designed to accommodate a variety of different species, including a barn owl nesting chamber and numerous features suitable for other nesting birds and roosting bats. Like the bat barns, the wildlife tower construction made use of materials reclaimed from the demolitions. Also like the bat barns, the wildlife tower was promptly inhabited, with bar owls successfully rearing a brood of chicks in the structure during the first breeding season after its construction and every year since. In 2017 the barn owls were joined by a pair of kestrels and a colony of honey bees, which made use of other parts of the tower.

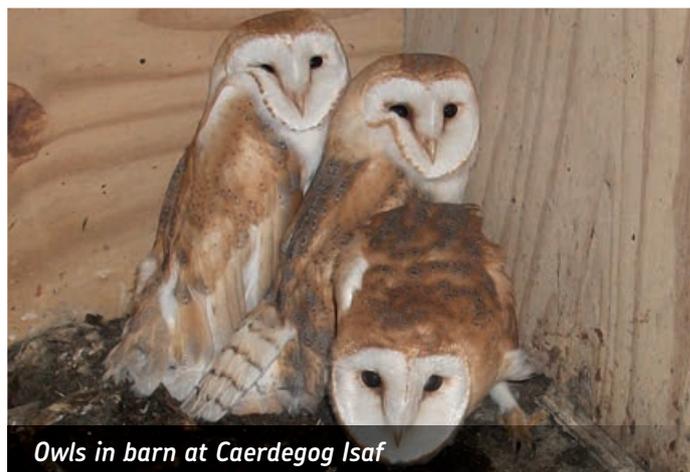
Owls in barn at Caerdegog Isaf

In addition to the wildlife tower, Horizon also converted a barn at Caerdegog Isaf in 2013 to provide another suitable location for nesting and roosting barn owls. Nesting barn owls were recorded for the first time in this barn in 2017.
